Lake Conway Canal Siltation Study

Technical Memorandum

August 2021

Orange County Environmental Protection Division

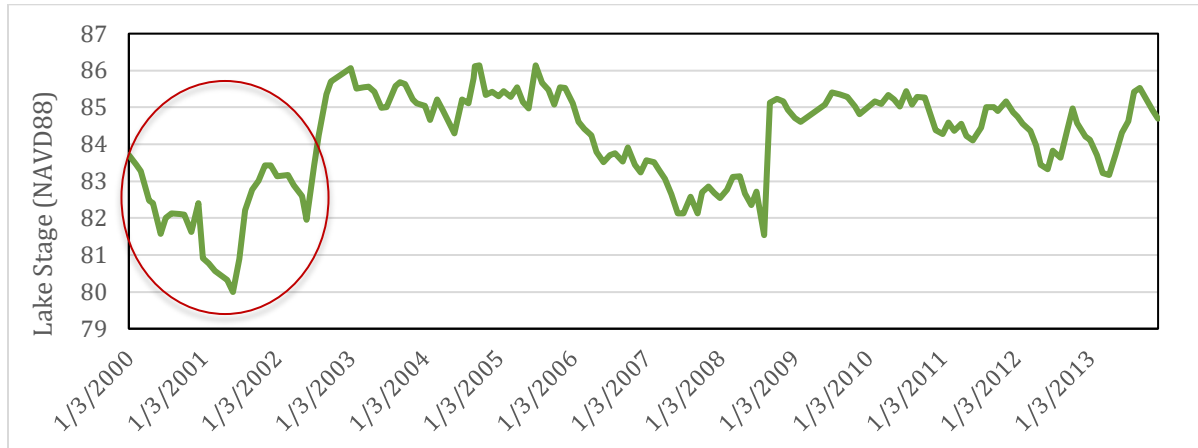
Figure 2-1: Historic Lake Stage for Lake Conway

this historic lake stage is presented in **Figure 2-1**. This figure illustrates the significant decrease in lake stage from 1999 to 2003 (shown in red). Based on a review of the 2010 report, there was no indication if the potential impact of the Daetwyler weir replacement on lake stage data was investigated/considered in calculations. Navigability and Navigability Ratings may have been influenced by the artificially low lake stages during this time because of construction activities. As further mentioned in **Section 4.2**, the lake stage calculated for the 2021 study used daily lake stage data from 2006 to 2021 from the Water Atlas, and therefore, does not include the lake stage during the construction of the Daetwyler weir.

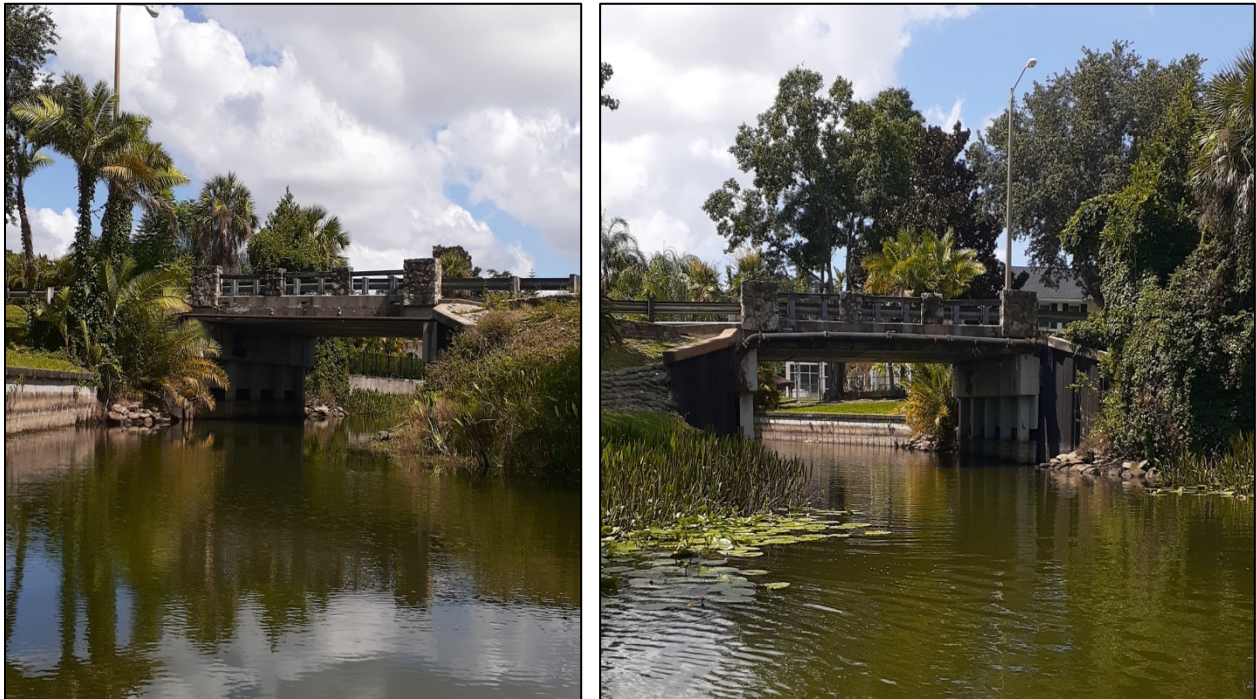
Photo 4-1: Gatlin Canal (5/4/2021, 5/5/2021) - The canal had little vegetation near the bridge and no vegetation in most of the canal

Gatlin Canal	Based on the findings presented in this report, it is not recommended to dredge the entirety of this canal at this time. It is recommended to inspect the area surrounding sample location 34 in the future, as the muck thickness is approximately 7.66 feet; however, the navigability is still 98.98%.	No
Harbour Oaks Canal	Because the Navigability Rating is at 148 years, it does not appear that dredging is necessary at this canal at this time.	No
Hoffner Canal	Based on the findings presented in this report, dredging does not appear to be necessary for the entirety of this canal at this time. It is recommended to inspect the areas surrounding sample locations 20, 26, 31, 140, 141, and 143 in the future, as the muck thickness is over 7 feet; however, the navigability is still above 98%.	No
Landings Canal	Because the Navigability Rating is at 147 years, dredging does not appear to be necessary at this time.	No

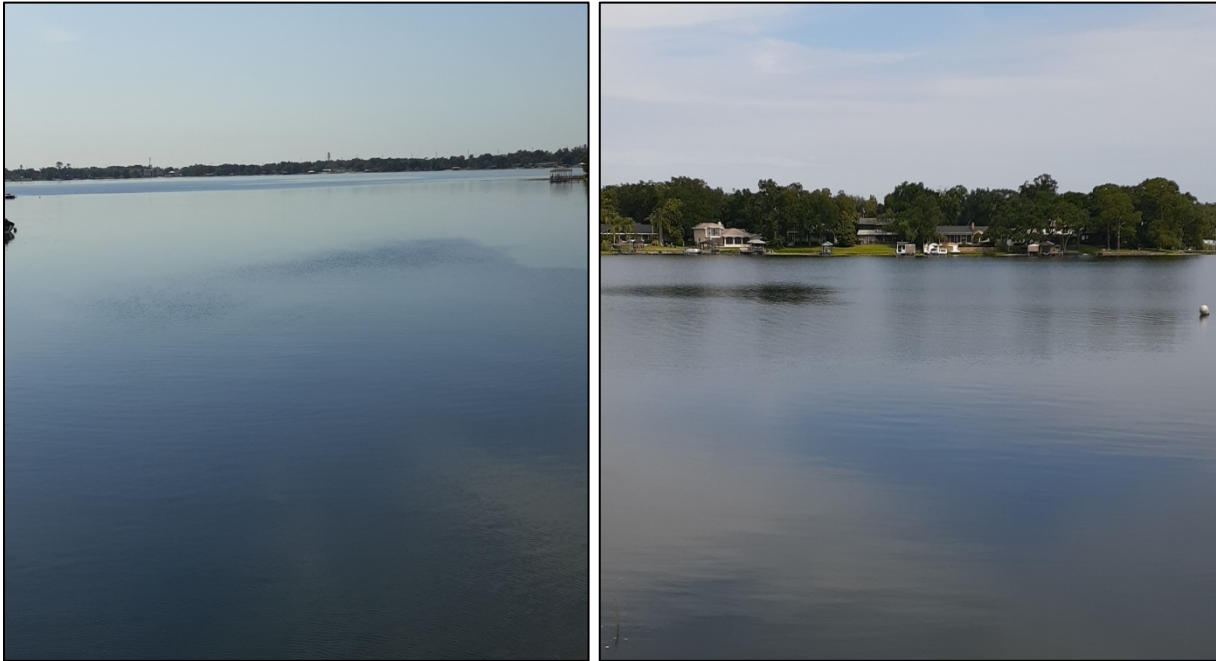
Photo 4-2: Nela Bridge Canal (4/22/2021) - Minimal aquatic vegetation was observed

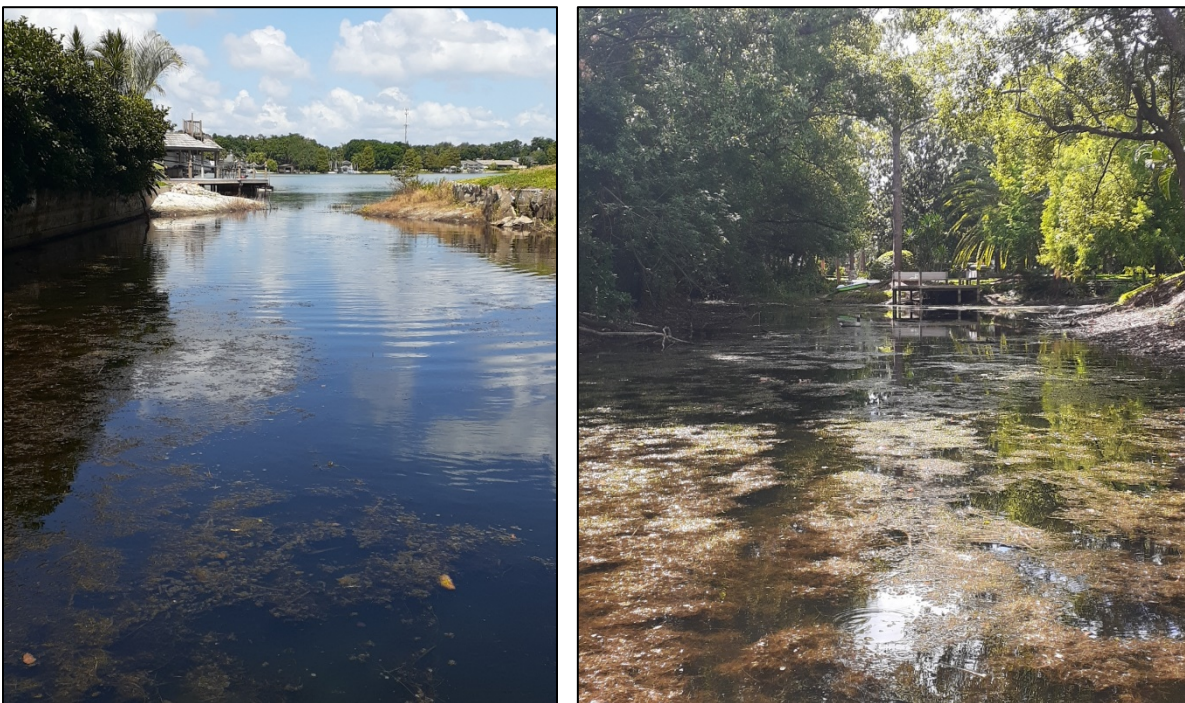
Photo 4-3: Wind Song Canal (5/5/2021) – Most of the canal is generally under 125 feet wide and contains significant aquatic and overhanging vegetation

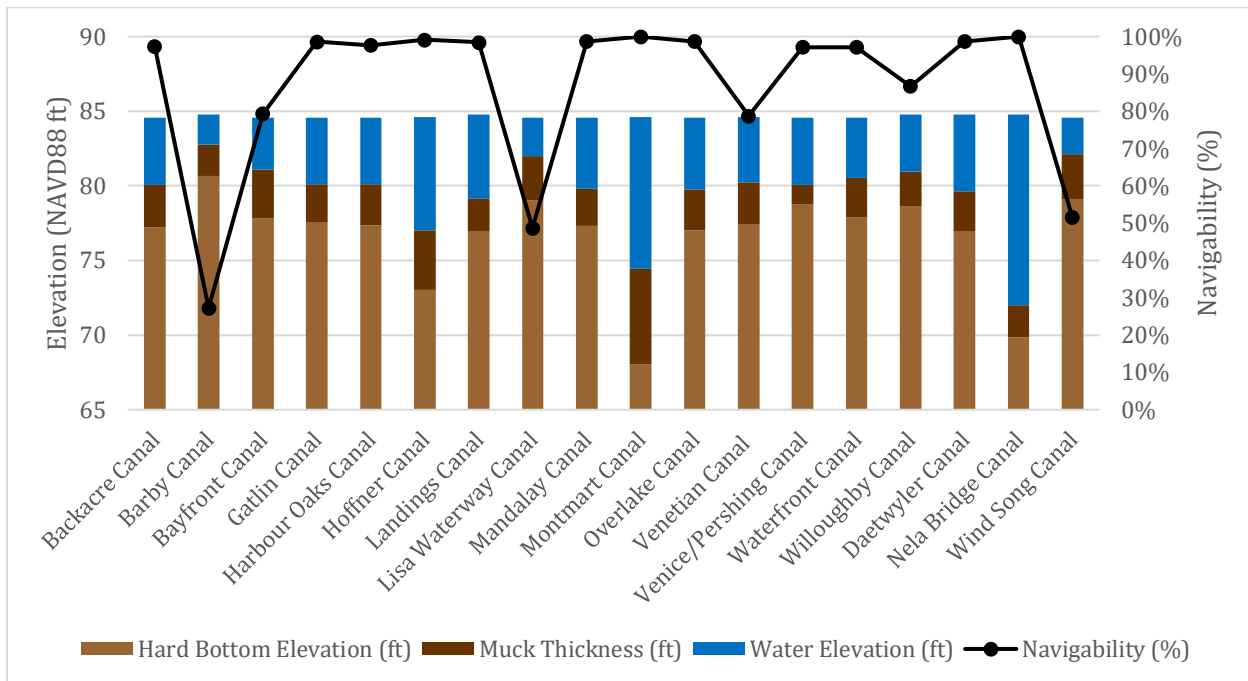
Figure 4-1: Average Canal Conditions

The average canal siltation conditions are presented in **Table 4-1** and includes the average top of muck elevation, the average hard bottom elevation, the average muck thickness, the average minimum navigability water surface elevation (summation of the top of muck elevation and MSND), and the average navigability percentile for each canal. **Figure 4-1** presents these results for each canal. It is noted that the average in **Table 4-1** were determined by averaging the respective results for all the sampling points within each canal. As mentioned earlier, green shading indicates a canal with an acceptable average navigability (above 20%) and yellow shading indicates an unacceptable average navigability.

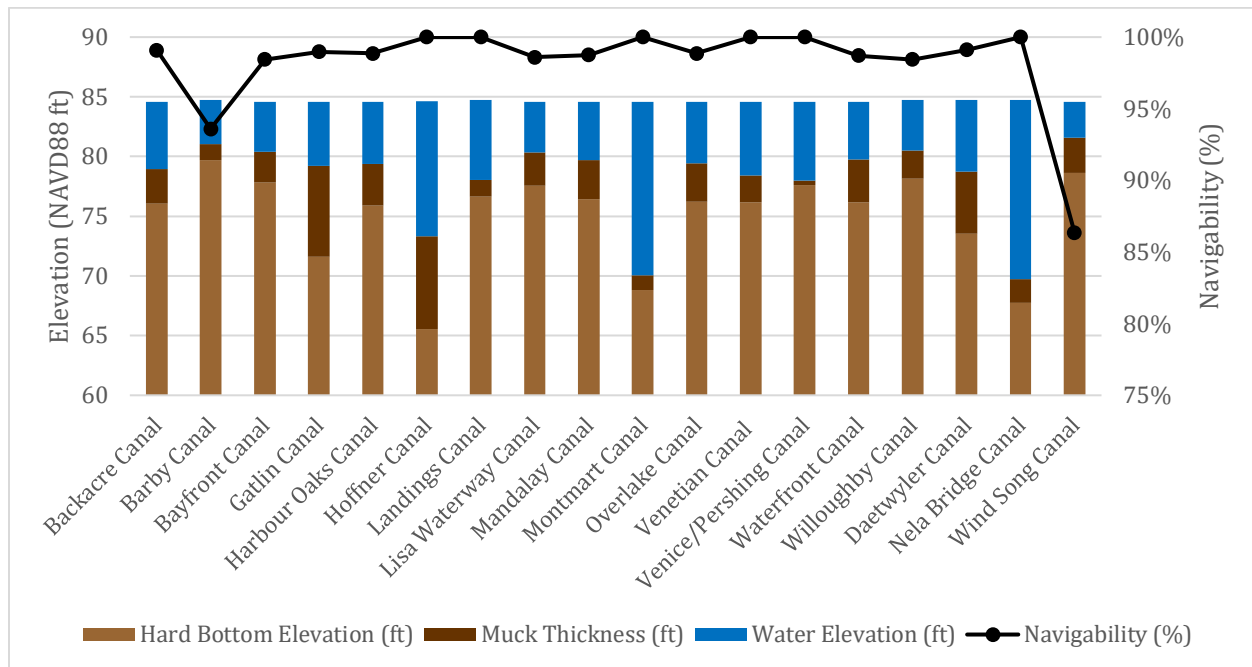
Figure 4-2: Minimum Canal Siltation Conditions (Best-Case)

The minimum canal siltation conditions (best-case condition) are presented in **Table 4-2** and **Figure 4-2**. The top of muck elevation, muck thickness, and hard bottom elevation for the minimum canal siltation condition sample location in each canal are presented. The minimum canal siltation condition in the current study is similar to the results from the 2010 study. The sample locations representing each canal presented in **Table 4-2** all had an acceptable navigability. This suggests that at these locations, the canal is in an acceptable condition to permit navigation. These canal locations tended to have lower top of muck elevation due to lower hard bottom elevations and/or limited muck thickness. However, it is noted that the muck thickness for the Gatlin canal and Hoffner canal was significant at 7.66 and 7.77 feet, respectively. This suggests that dredging would further increase the navigability of these two canals as well as potentially provide a water quality benefit in the form of lake muck reduction.

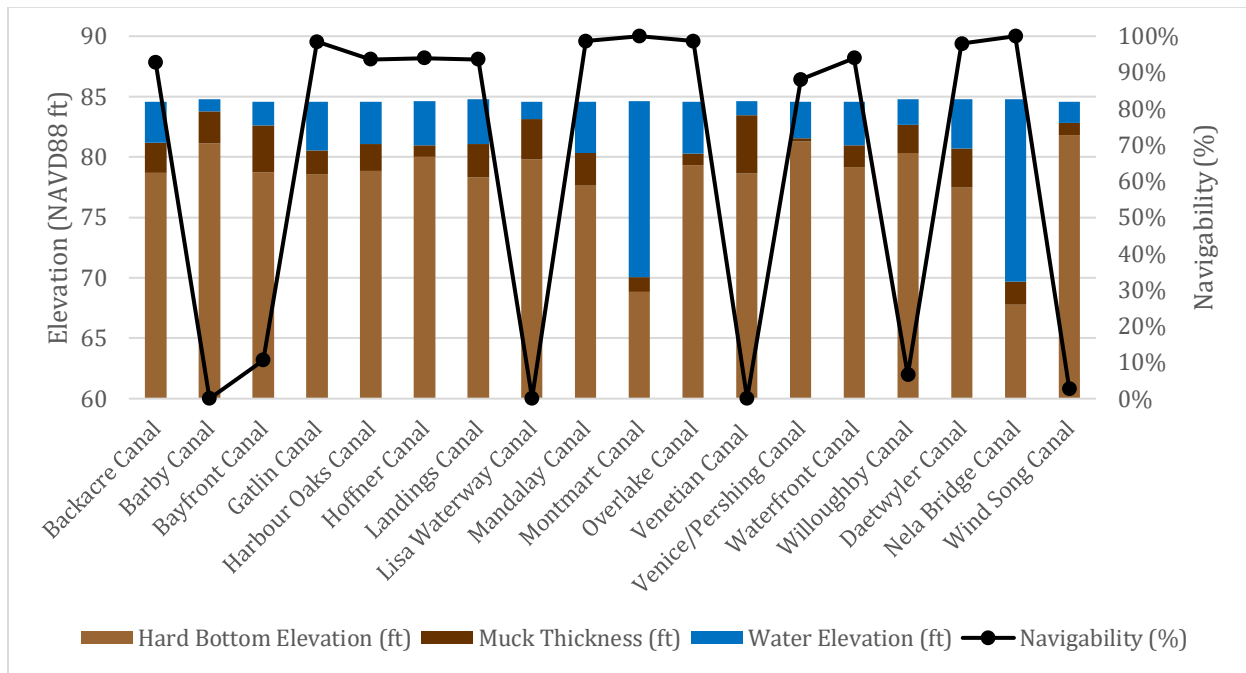
Figure 4-3: Maximum Canal Siltation Conditions (Worst-Case)

The maximum canal siltation condition is presented in **Table 4-3** and **Figure 4-3**. The top of muck elevation, muck thickness, and hard bottom elevation for the sample location in each canal with the lowest navigability, which corresponds with the worst-case canal conditions. The maximum canal siltation condition (worst-case condition) is similar to the maximum siltation condition in the 2010 report. For the current study, six of the canals had unacceptable navigability conditions, which suggests that maintenance may be required to improve navigability, see **Table 4-3**. It is noted that, the results provided in this section are representative of one sample location in each canal. Inspection of the surrounding locations is recommended when evaluating maintenance or dredging activities.

Based on the results from this analysis, most of the canals that demonstrated unacceptable navigability conditions had greater muck thickness than the canals with acceptable navigability conditions. Therefore, removal of muck thickness appears to be warranted to improve the navigability of these canals. The remaining canals had a minimum navigability rating of 88% for the worst-case canal navigability, which suggests that these canals are sufficiently clear of muck to adversely impact navigability.

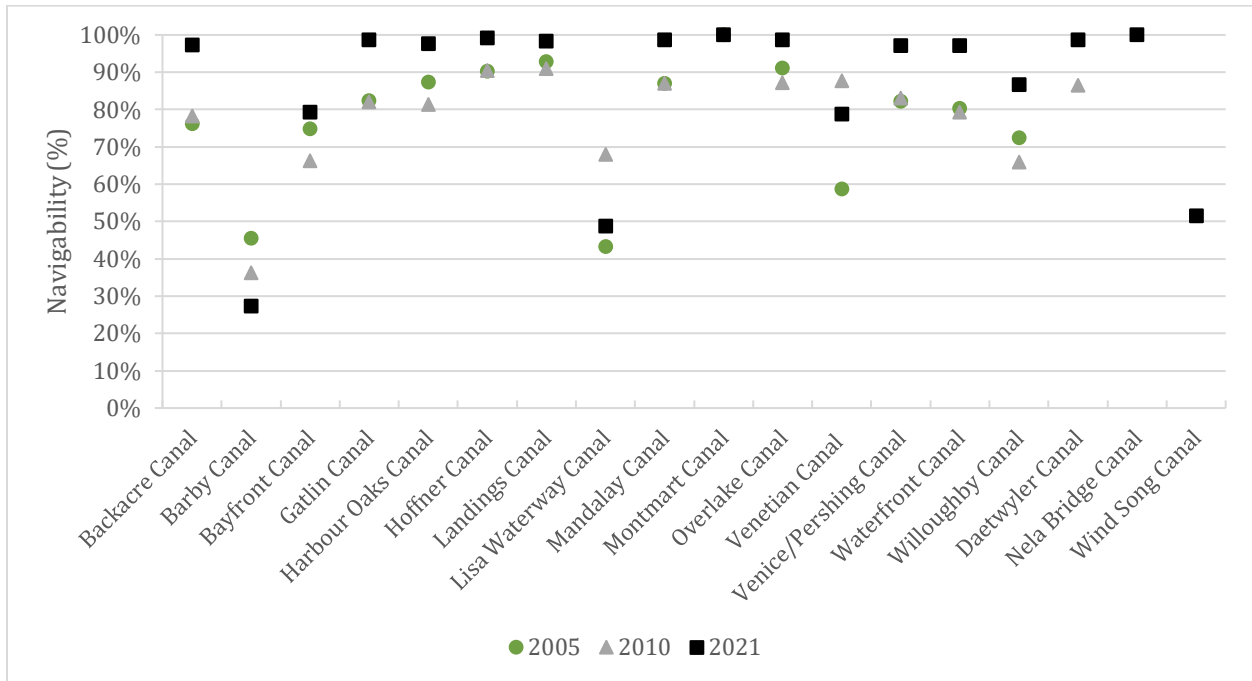
Figure 4-6: Scatterplot for the Average Conditions of Each Canal

The average navigability currently represents an acceptable condition for all the canals, however the annual change in average navigability for some canals currently represents an unacceptable condition. To further illustrate the change in average navigability between 2005, 2010, and 2021, a scatterplot is presented in **Figure 4-6**. In **Figure 4-6**, most of the canals had an improved average navigability from 2010 to 2021. This suggests that these canals would not immediately require dredging. However, some of the canals had a decrease in average navigability, which suggests these canals may require dredging or maintenance sooner as the canal may become unnavigable over time. For example, Lisa Waterway had an acceptable average navigability change between 2005 and 2010, which illustrates an improving canal condition. However, the canal had an unacceptable average navigability change between 2010 and 2021, which suggests that at the current average annual rate of change in navigability, the canal will need maintenance sooner than most other canals.
