Lake Conway Canal Siltation Study

Technical Memorandum

August 2021

Orange County Environmental Protection Division

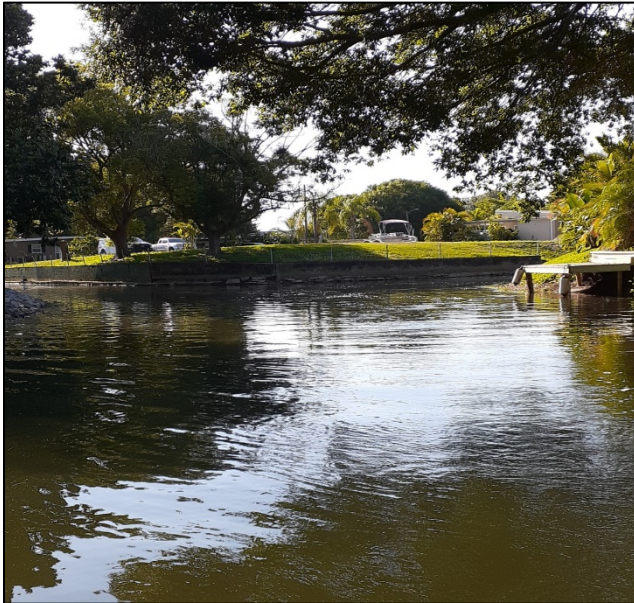
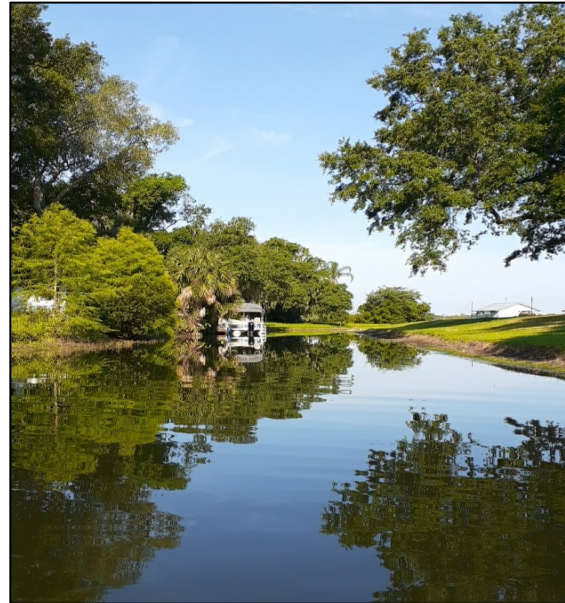
Photo 4-3: Wind Song Canal (5/5/2021) – Most of the canal is generally under 125 feet wide and contains significant aquatic and overhanging vegetation

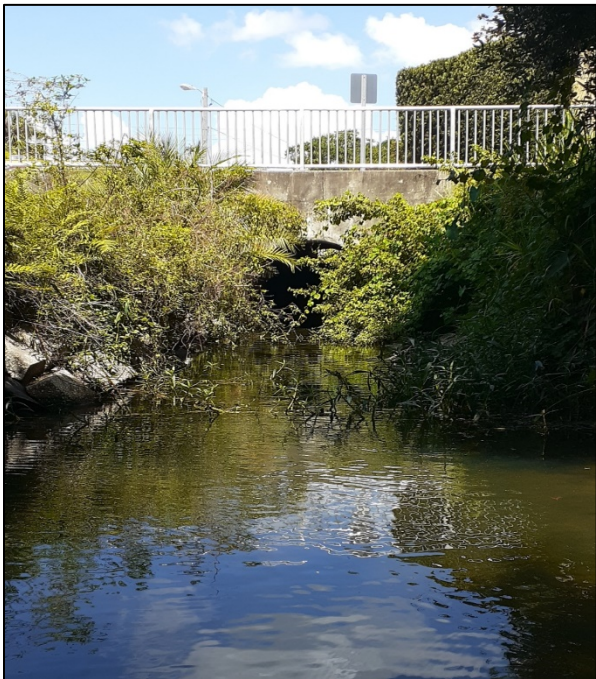
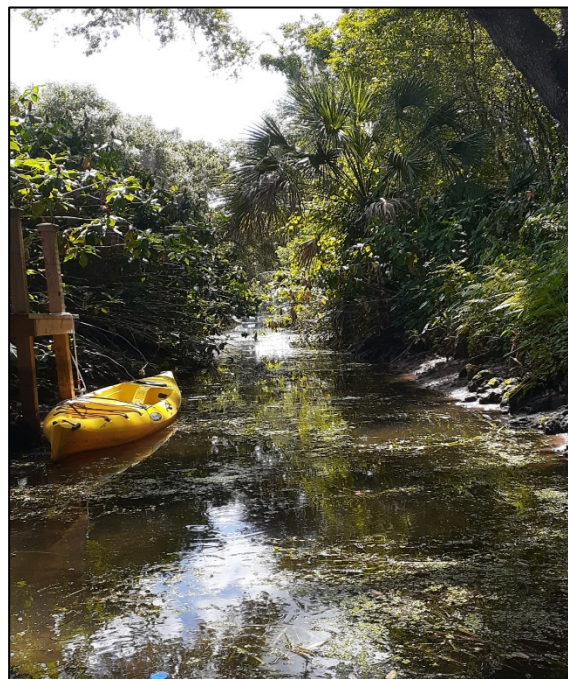
Photo 4-4: Willoughby Canal (4/22/2021) – The canal is generally under 50 feet wide with no aquatic vegetation and some overhanging vegetation

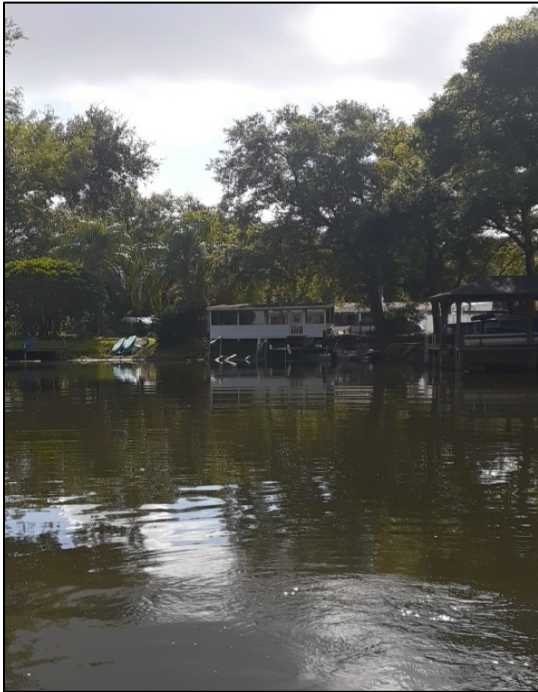
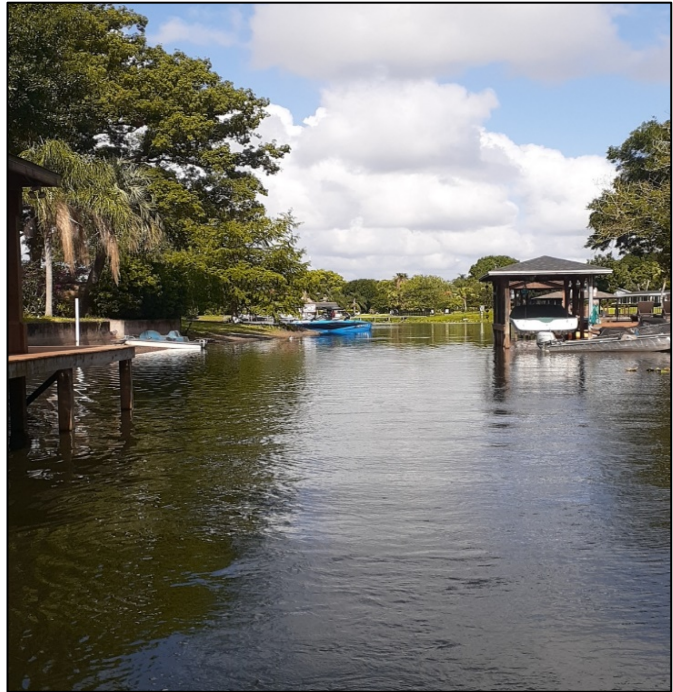
Photo 4-5: Lisa Waterway Canal (5/4/2021, 5/5/2021) - The canal width is generally under 50 feet and contains significant overhanging and aquatic vegetation

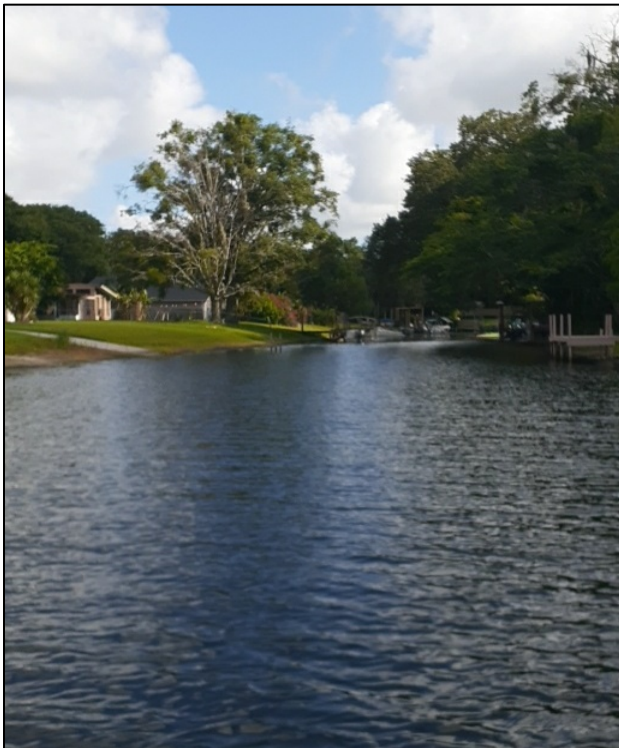
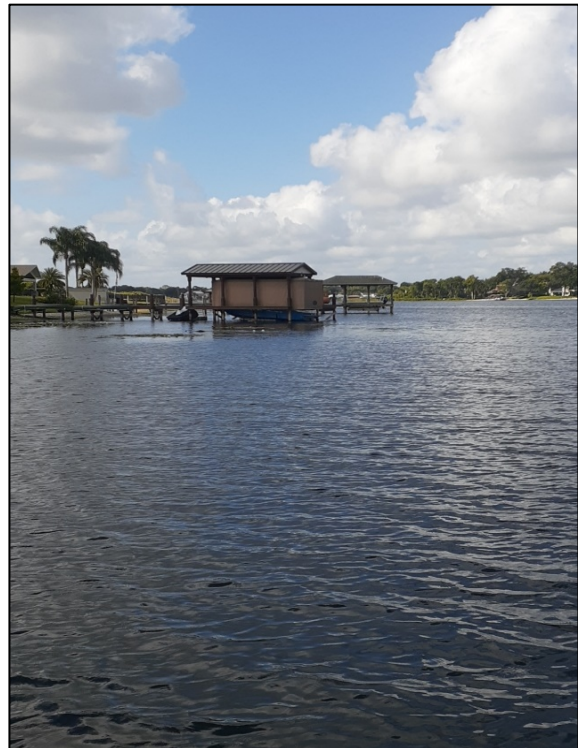
Photo 4-6: Waterfront Canal (5/4/2021) – Most of the canal is open with little overhanging vegetation, the canal width varies with parts less than 75 feet wide

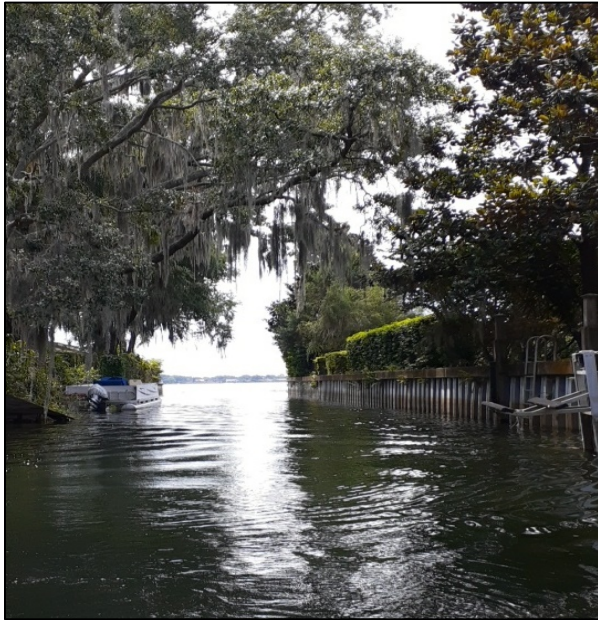
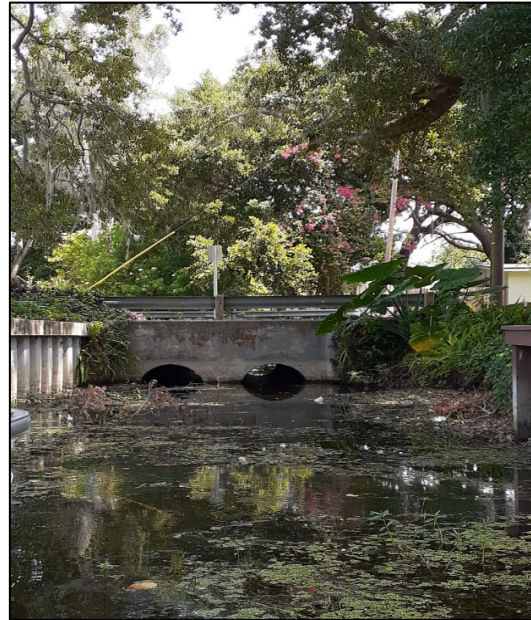
Photo 4-7: Venice/Pershing Canal (5/4/2021) – Most of the canal is generally over 250 feet wide with little overhanging vegetation

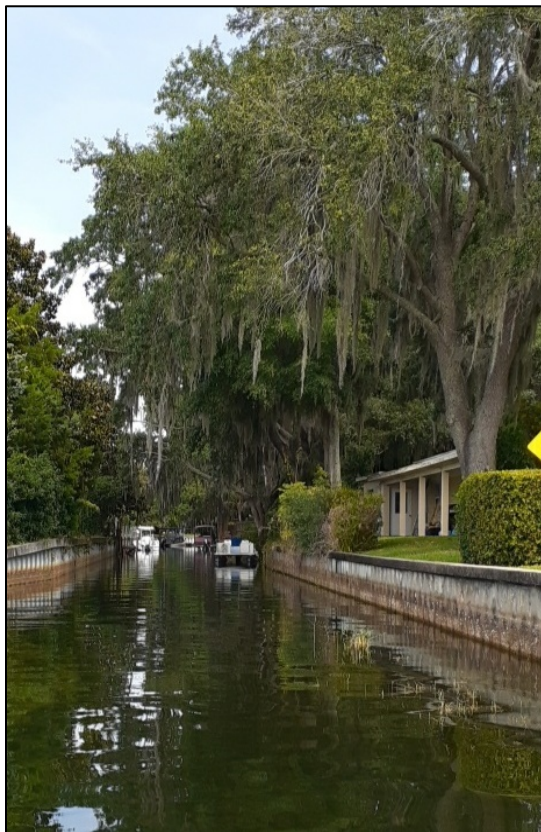
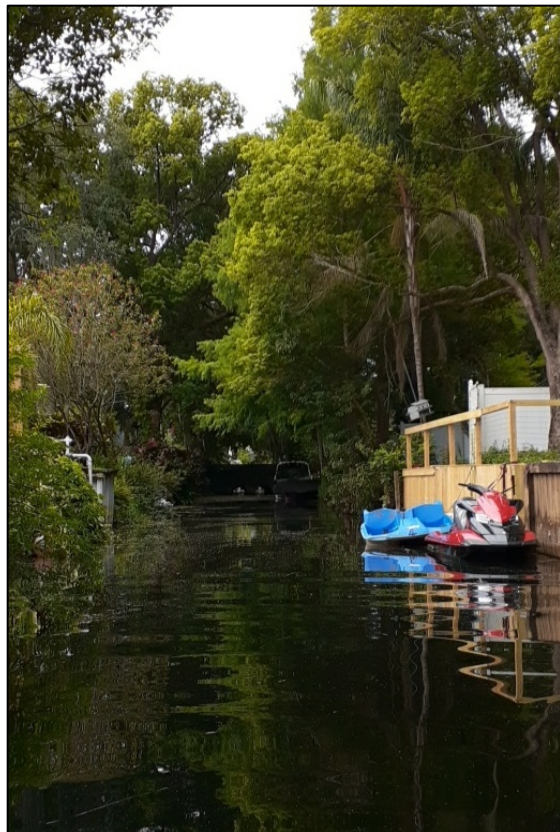
Photo 4-8: Venetian Canal South (4/28/2021) - The canal is generally under 50 feet wide, with significant overhanging and aquatic vegetation present

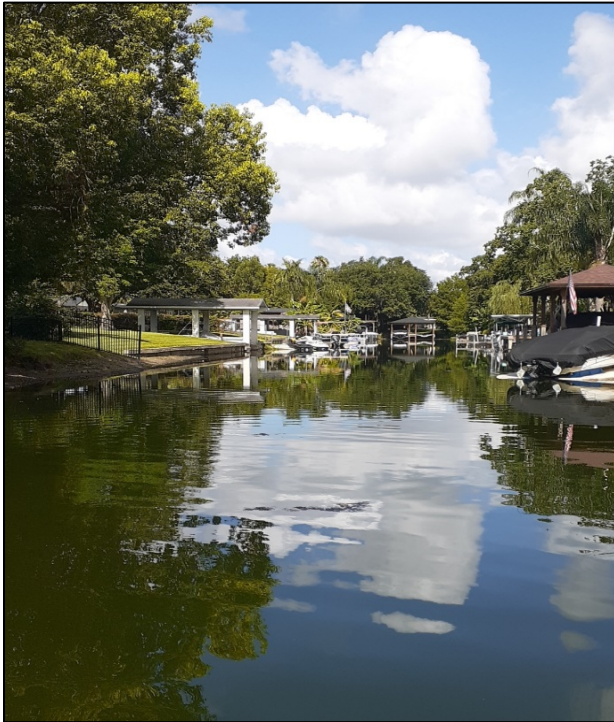
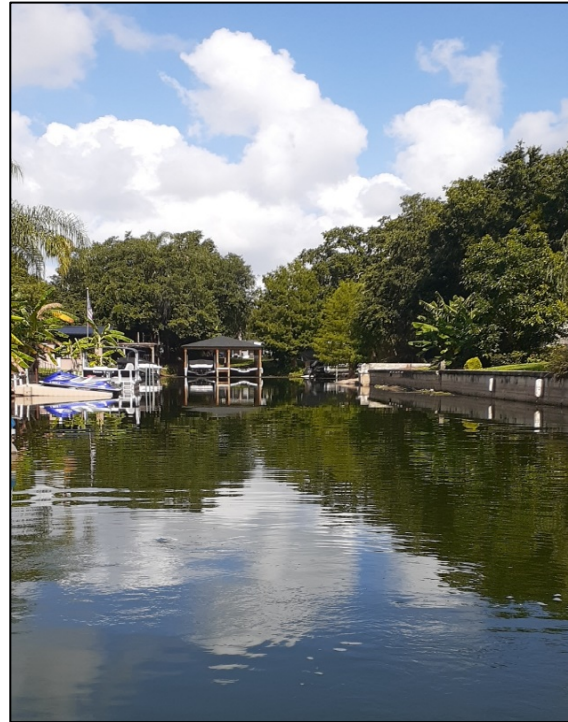
Photo 4-9: Venetian Canal North (4/28/2021) - The canal is generally under 50 feet wide with overhanging vegetation and retaining walls along the banks

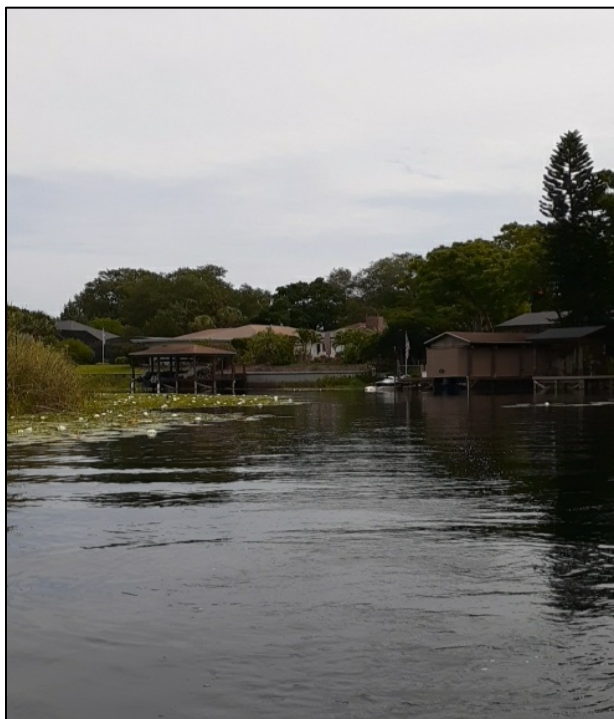
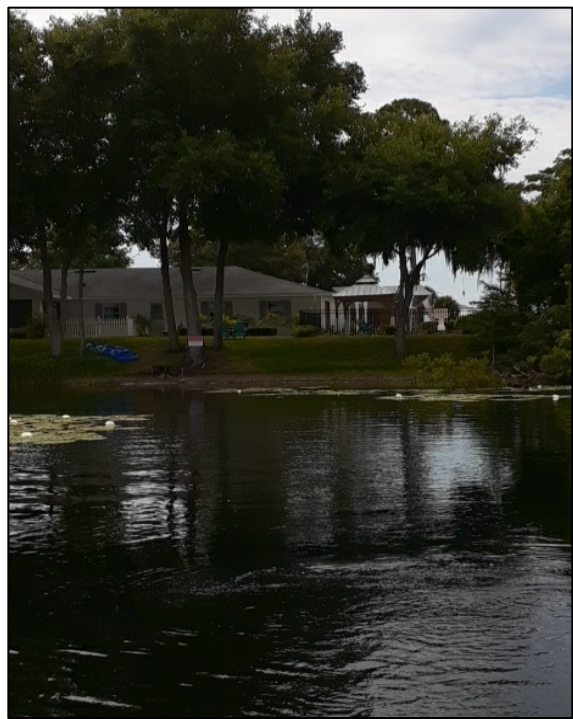
Photo 4-10: Overlake Canal (5/4/2021) - Most of the canal is approximately 50 feet wide and has a retaining wall along the banks

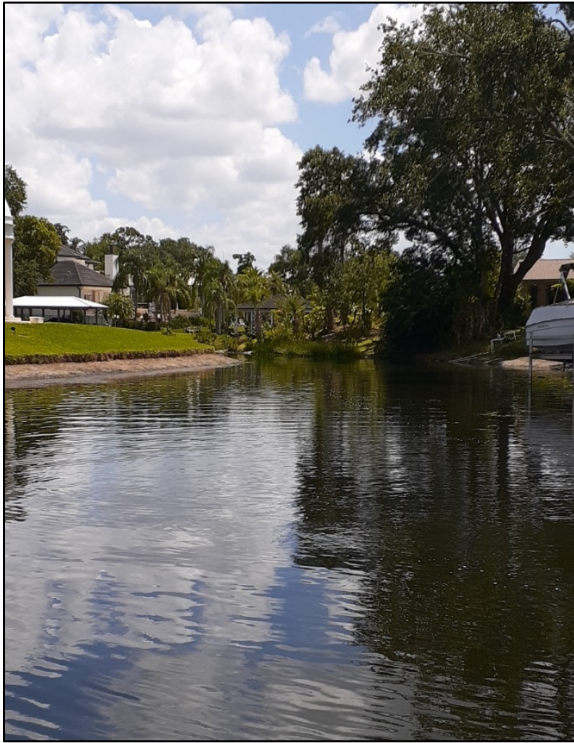
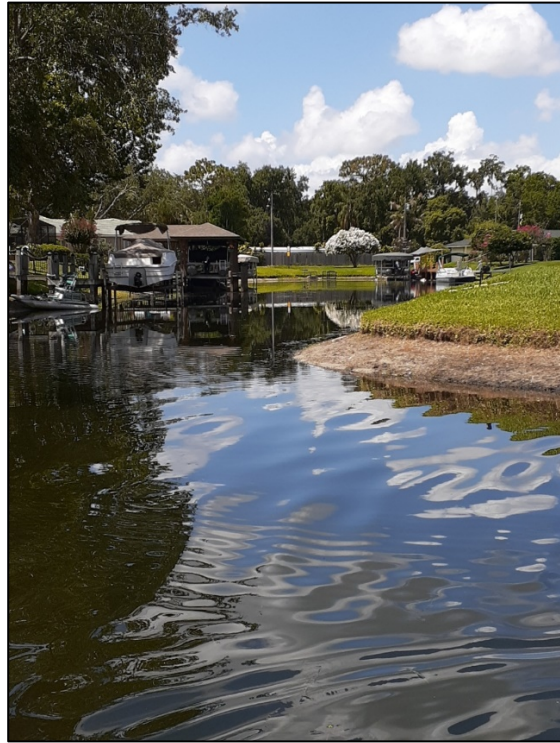
Photo 4-11: Montmart Canal (4/29/2021) – Most of the canal is generally under 175 feet wide with some aquatic vegetation

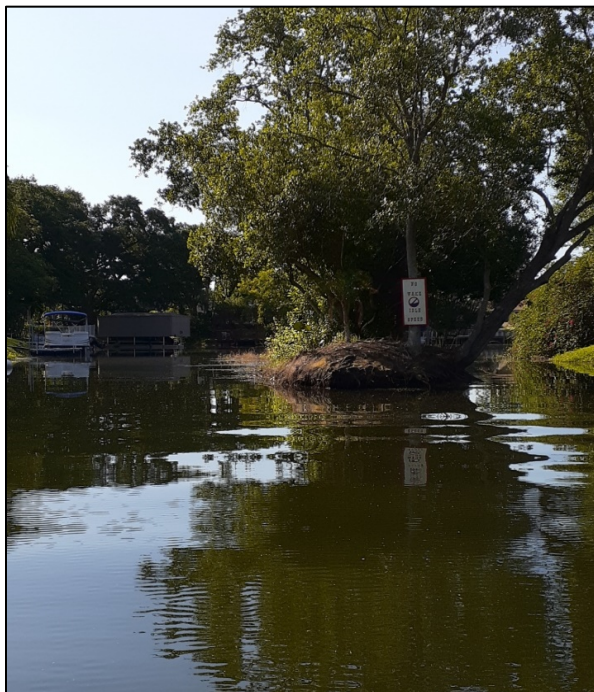
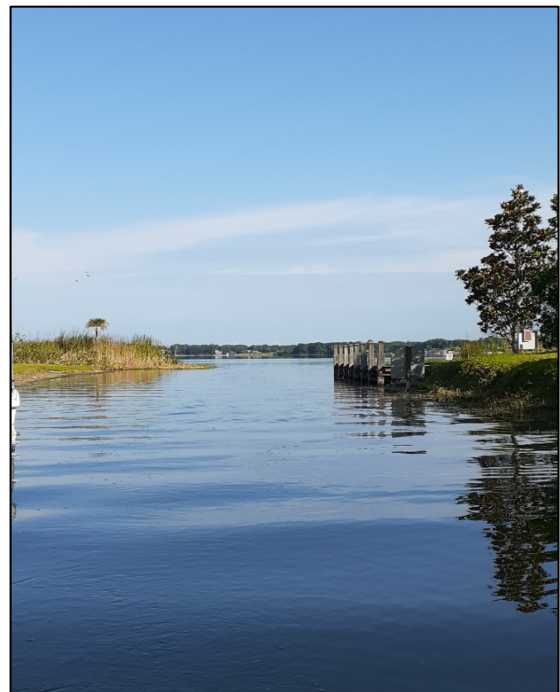
Photo 4-12: Mandalay Canal (5/4/2021) - The canal is generally under 100 feet wide with no aquatic and little overhanging vegetation

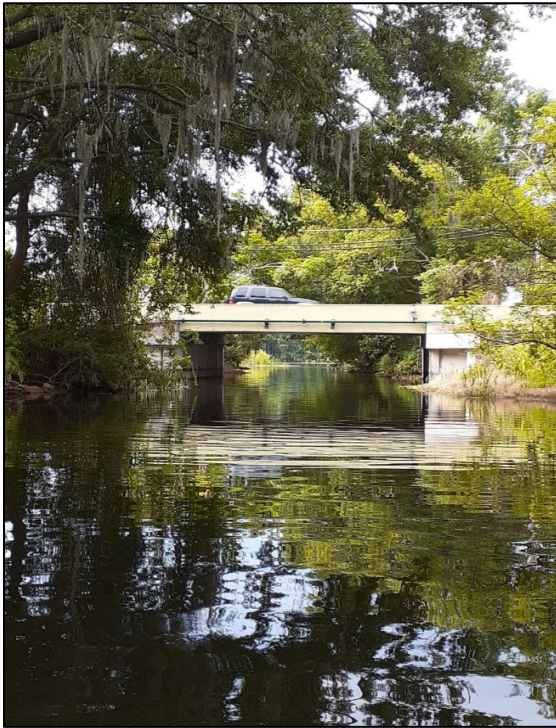
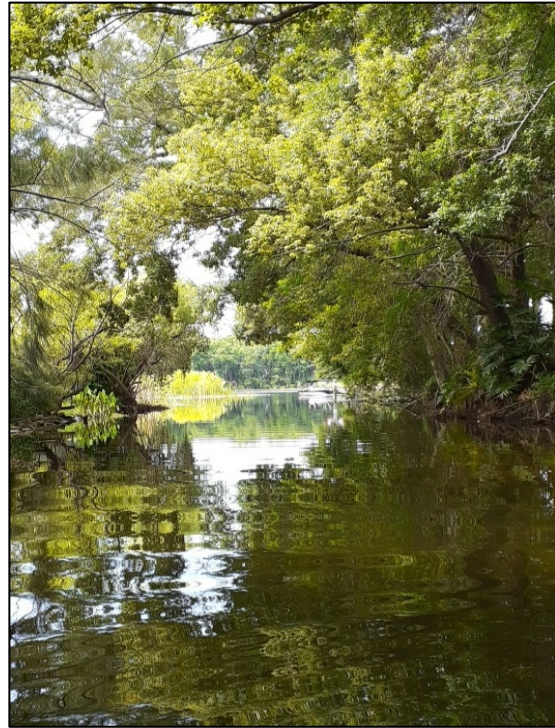
Photo 4-13: Landings Canal (4/22/2021) - The canal width varied from under 75 feet to under 225 feet, with some overhanging vegetation

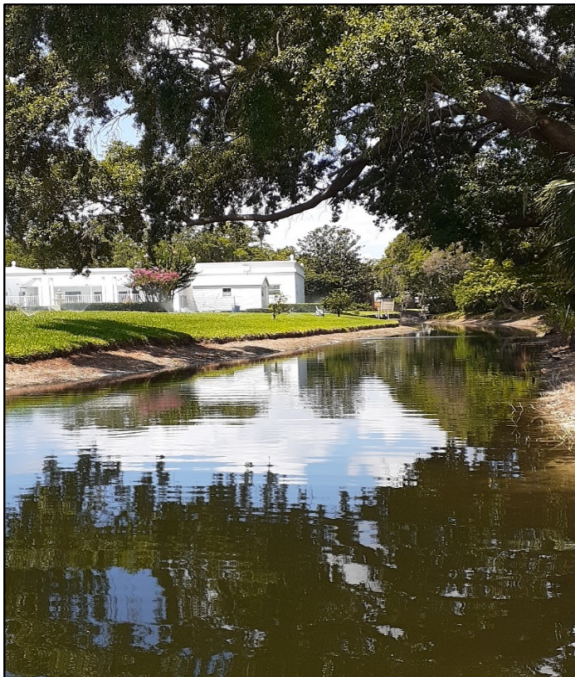
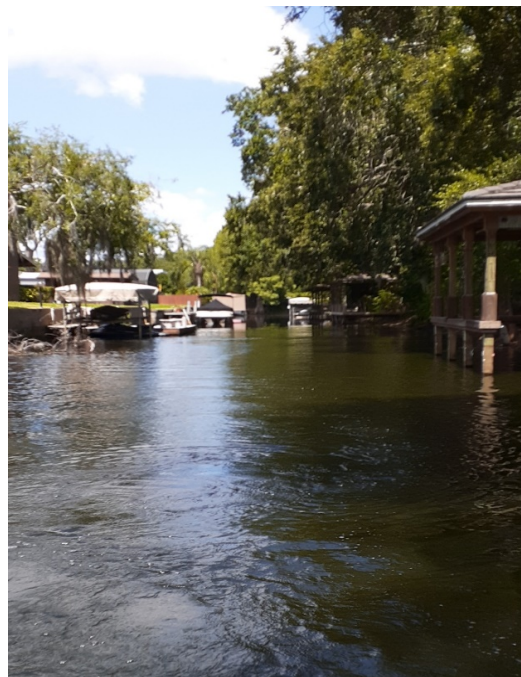
Photo 4-14: Hoffner Canal (4/23/2021, 4/28/2021) - The canal width varied from generally under 50 feet in certain parts of the canal to generally under 900 feet, with a large amount of overhanging vegetation

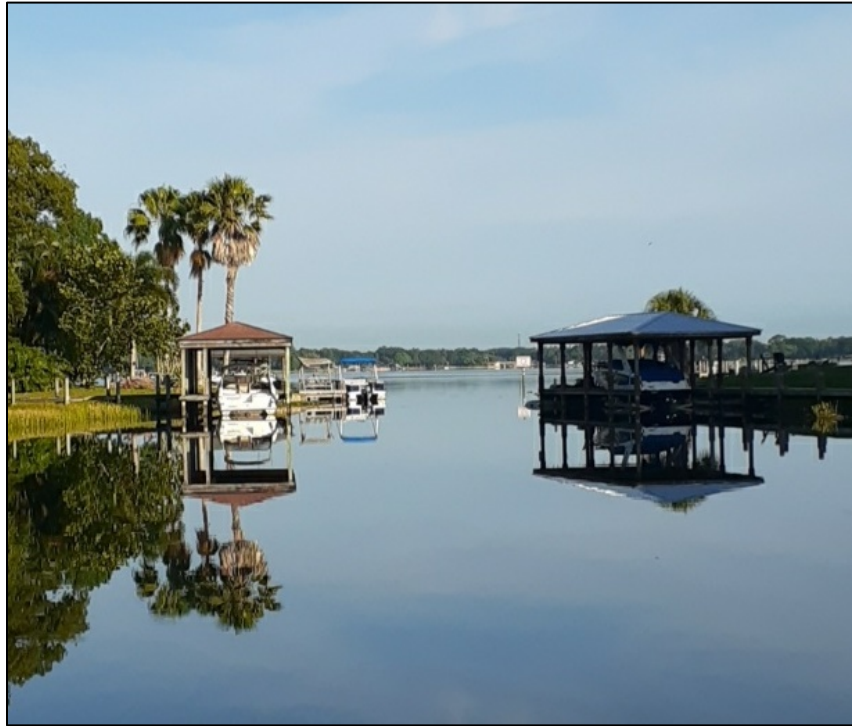
Photo 4-15: Harbour Oaks Canal (5/4/2021, 5/5/2021) - The canal is generally under 50 feet wide, with some overhanging vegetation

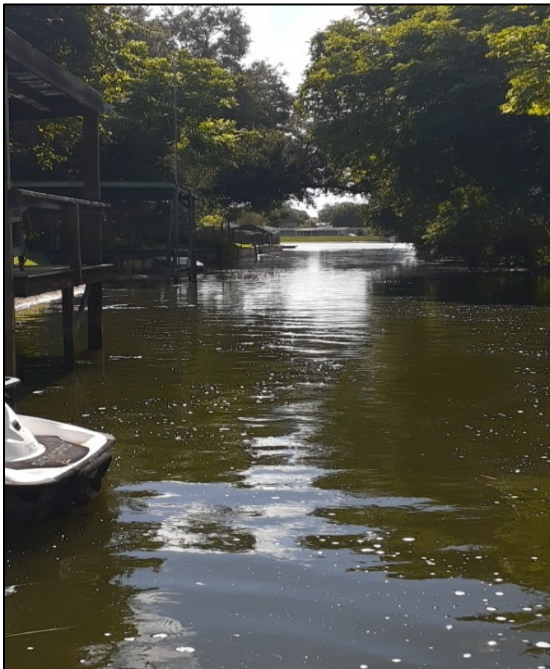
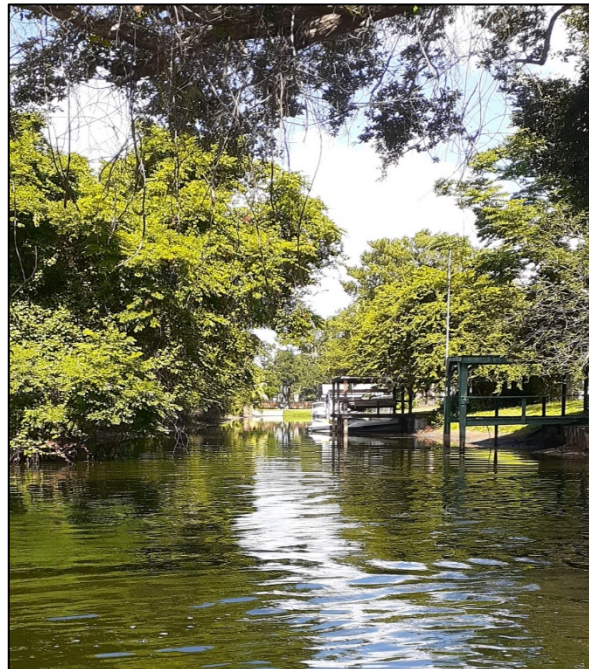
Photo 4-16: Daetwyler Canal (4/22/2021) – Most of the canal is generally under 200 feet with some areas less than 100 feet wide. The canal appears open with no aquatic nor overhanging vegetation but with some boat docks

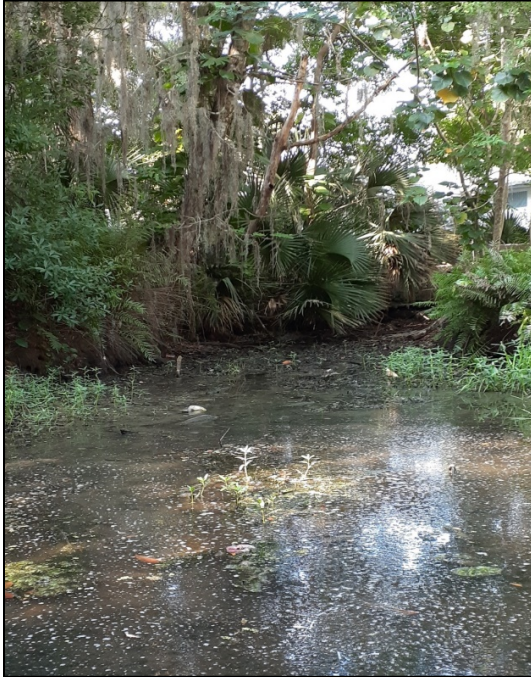
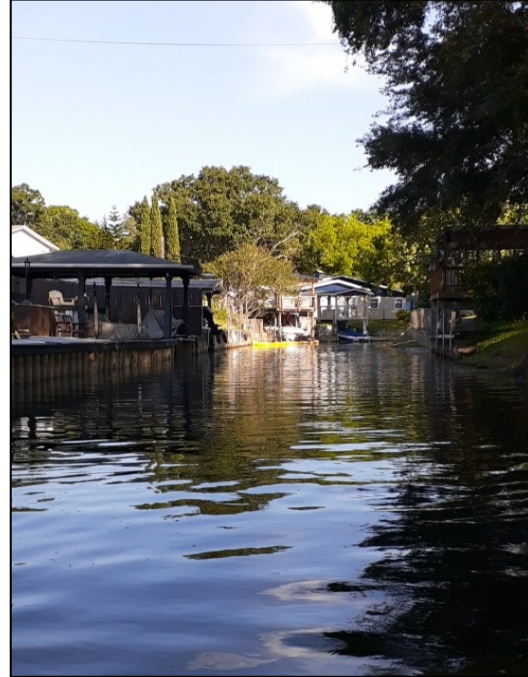
Photo 4-17: Bayfront Canal (5/4/2021) – The canal is generally under 75 feet wide, with a large amount of overhanging vegetation but no aquatic vegetation

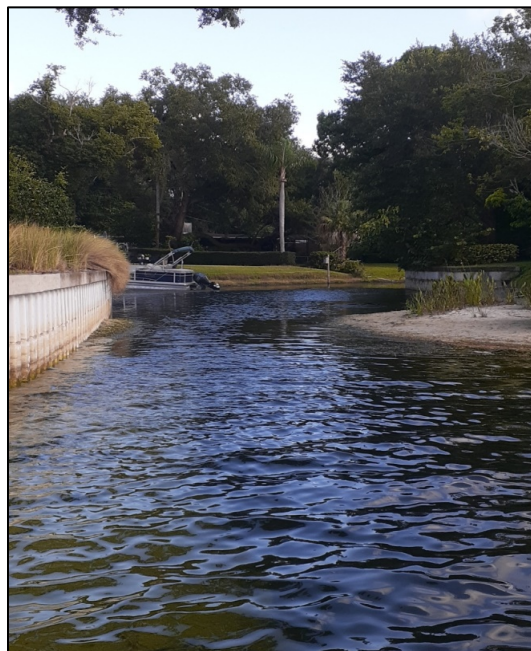
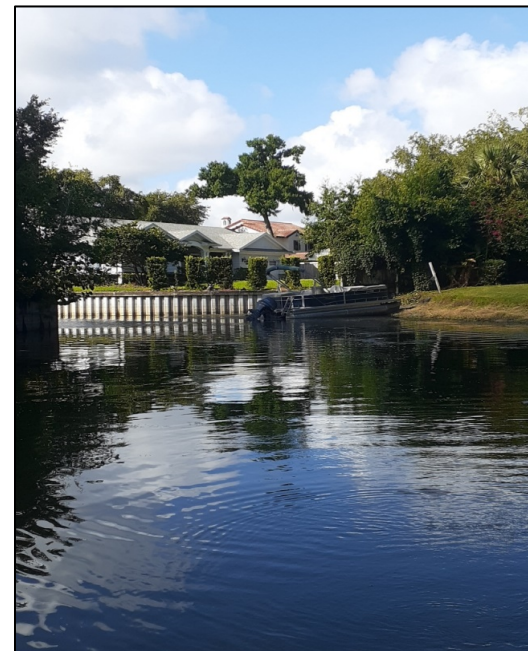
Photo 4-18: Barby Canal (4/22/2021) - The canal is generally under 50 feet wide, with a large amount of aquatic vegetation, some overhanging vegetation, and a retaining wall along the banks

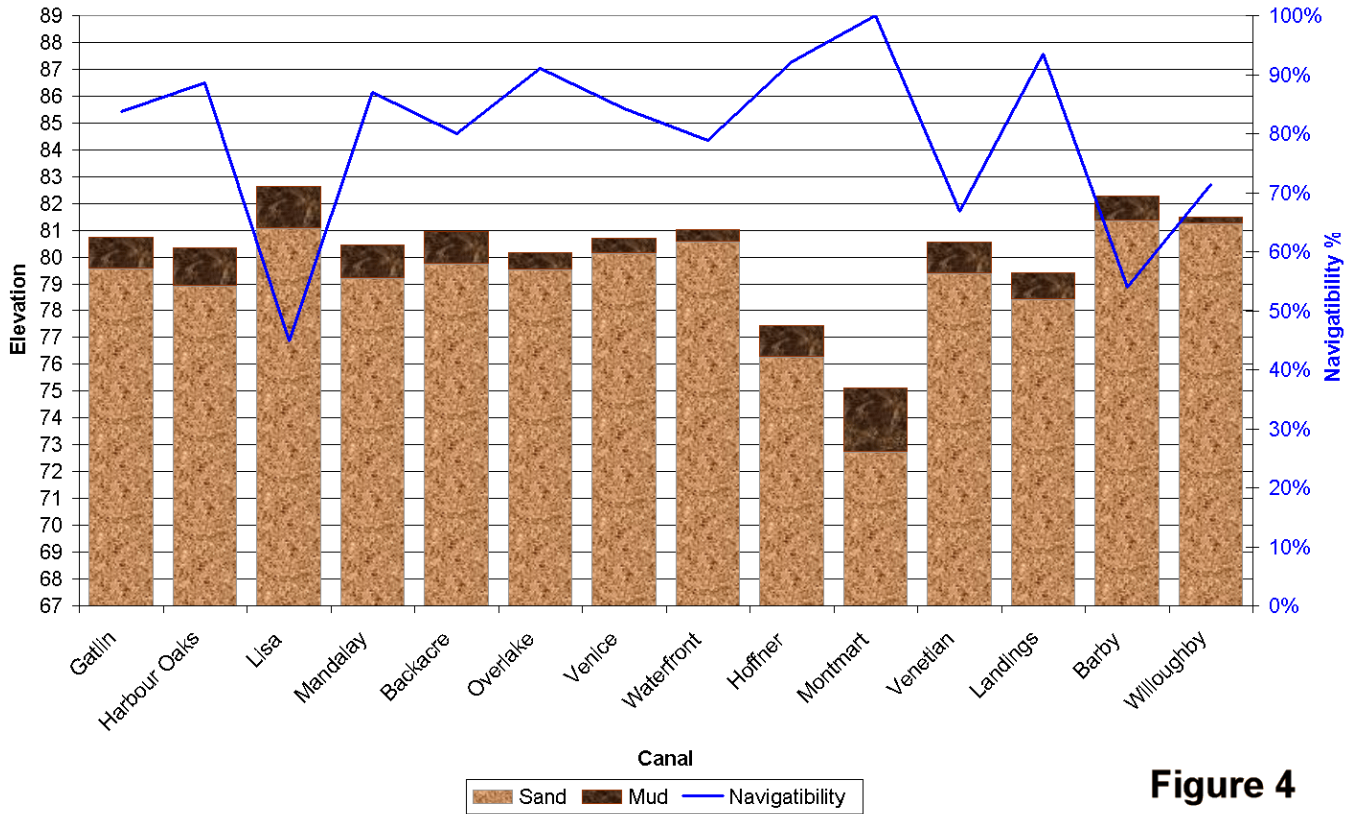
Figure 4

A summary of the average state of the canals in 2005 and 2010 is shown visually in Figures 4 and 5 respectively. These show the average bottom elevation of each canal with the average mud thickness stacked on top. Here the Navigability (read off the right hand scale) is an average of the Navigability of each probe location in the canal. These are the best charts to quickly compare the condition of each canal.

Lake Conway 2005 Average Canal Bottom Elevations

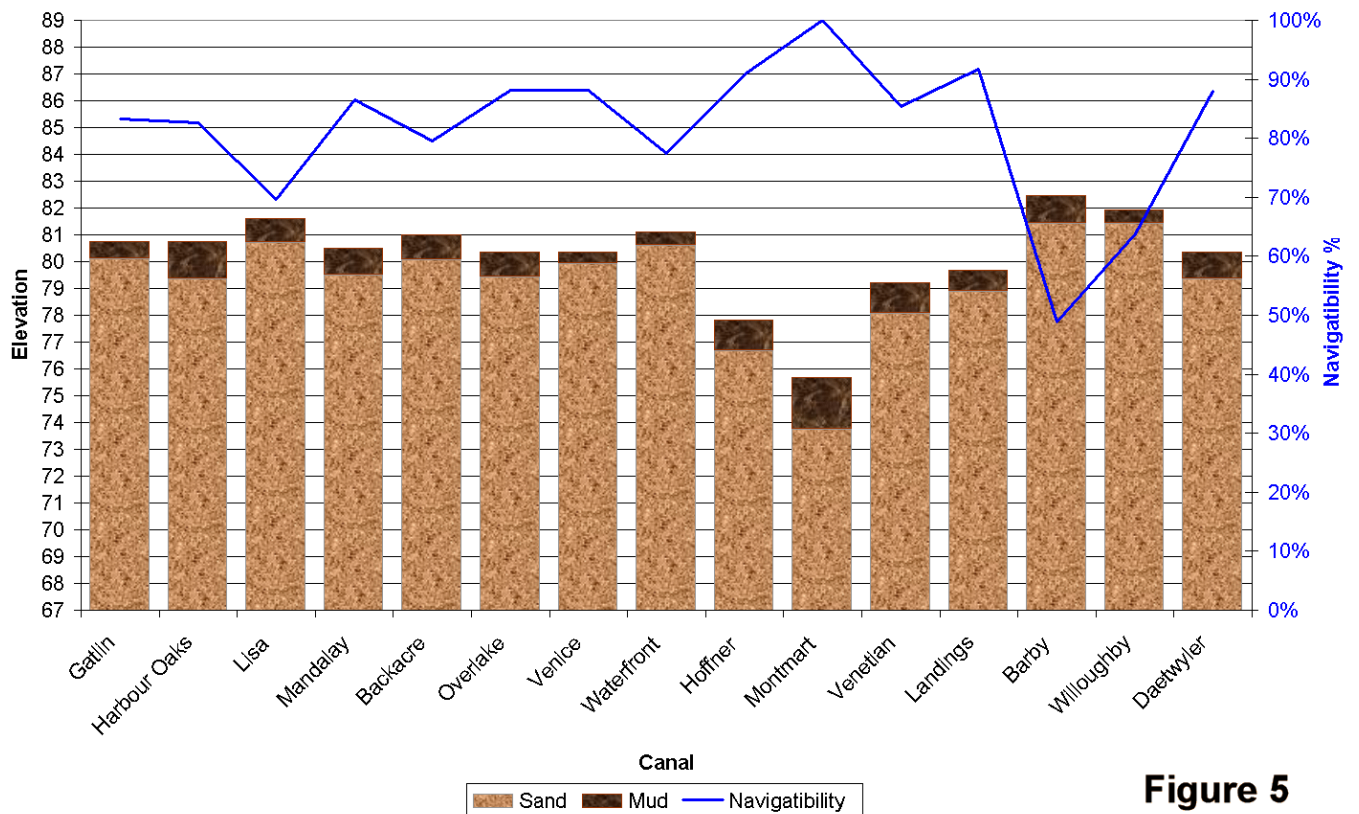
Figure 5

Lake Conway 2010 Average Canal Bottom Elevations

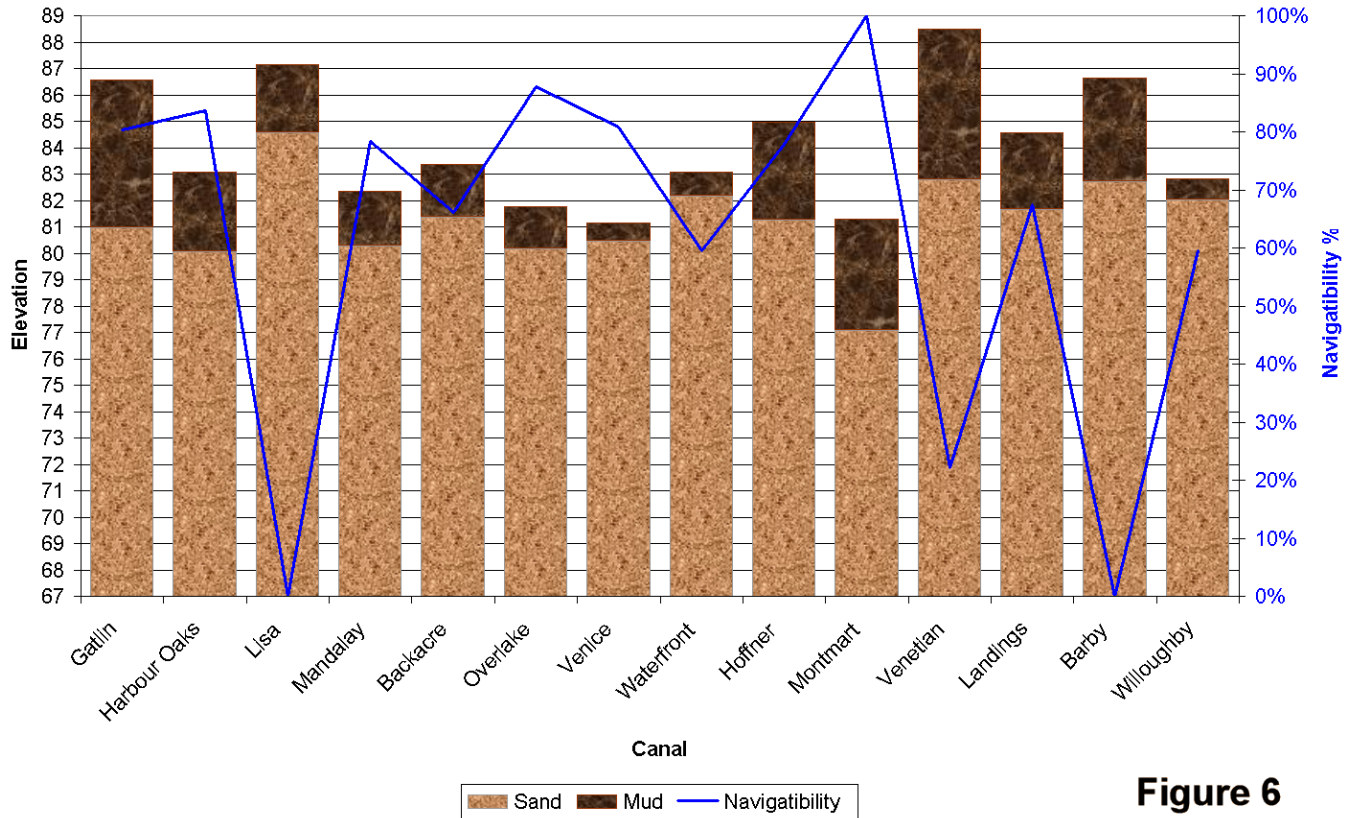
Figure 6

The highest canal elevations and thickest mud for each canal in both 2005 and 2010 is illustrated in Figures 6 and 7 respectively. These charts are a reasonable second check for potential restricted points in the canals. The sand bars illustrate the highest hard bottom in the canals. The mud bar on top of them illustrates the thickest mud in each canal. The top of the mud bar does not represent a real elevation in the canal since the thickest mud usually occurs in the deeper parts of the canal while the thinnest mud usually occurs at the shallowest locations (shown in this chart). The Navigability for this chart was determined from the actual shallowest mud elevation. For the most part the shallow areas occur at either the entrance or the end of the canals.

Lake Conway 2005 Highest Canal Bottom Elevations

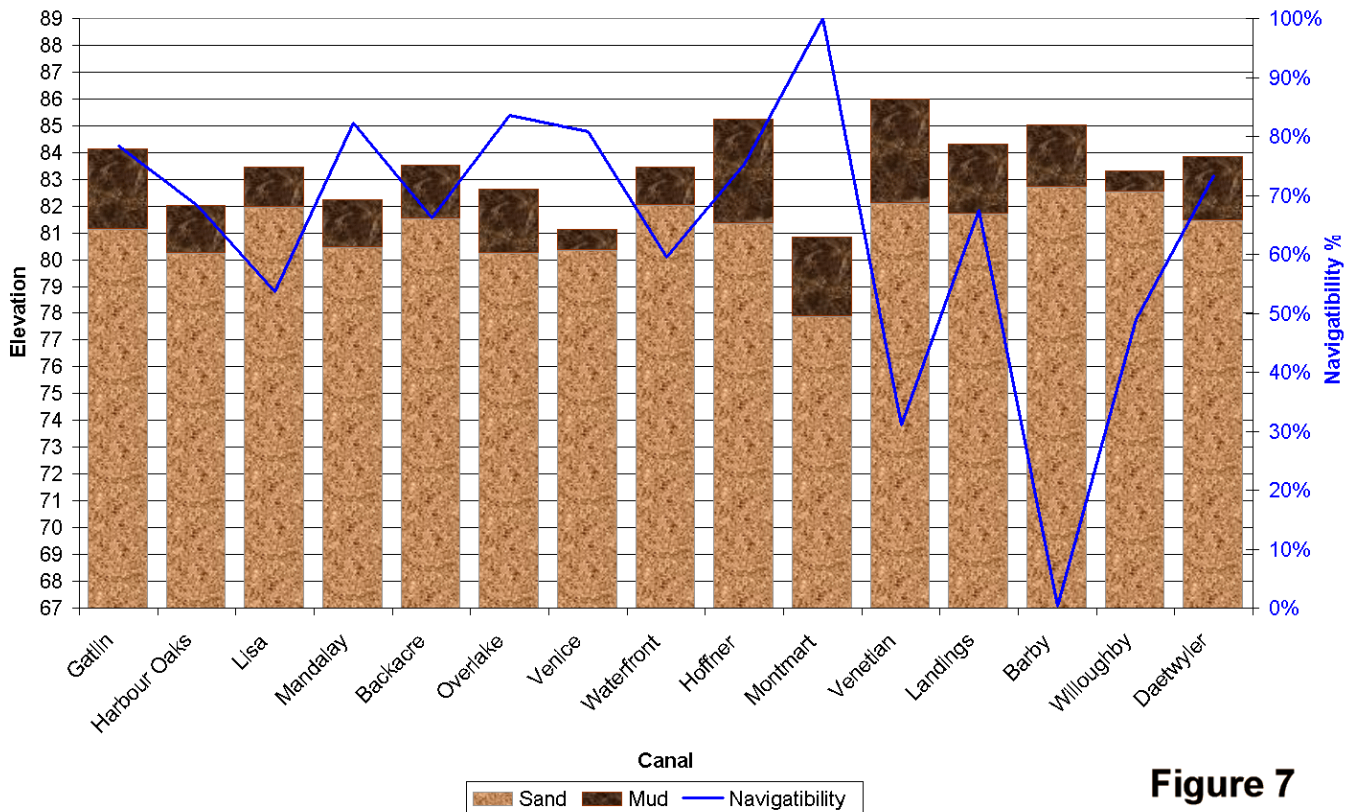
Figure 7

Lake Conway 2010 Maximum Canal Bottom Elevations

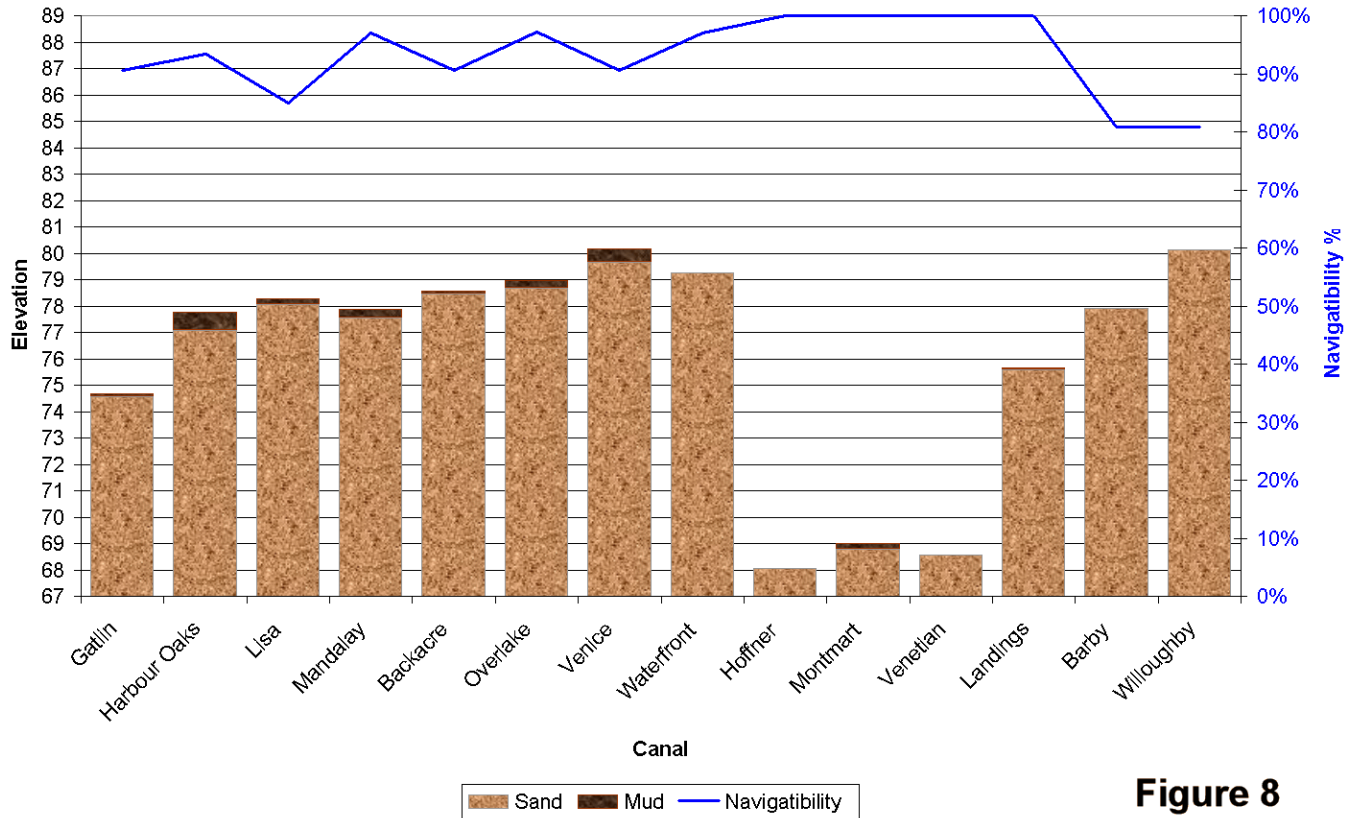
Figure 8

The lowest canal elevations and thinnest mud for each canal in 2005 and 2010 is illustrated in Figures 8 and 9 respectively. These charts show the elevation of the deepest holes in each canal. The Navigability shown here is for these deep locations only. To see the true relationship of the mud and bottom elevation at each probe location use the Canal Profiles described in the next section.

Lake Conway 2005 Lowest Canal Bottom Elevations

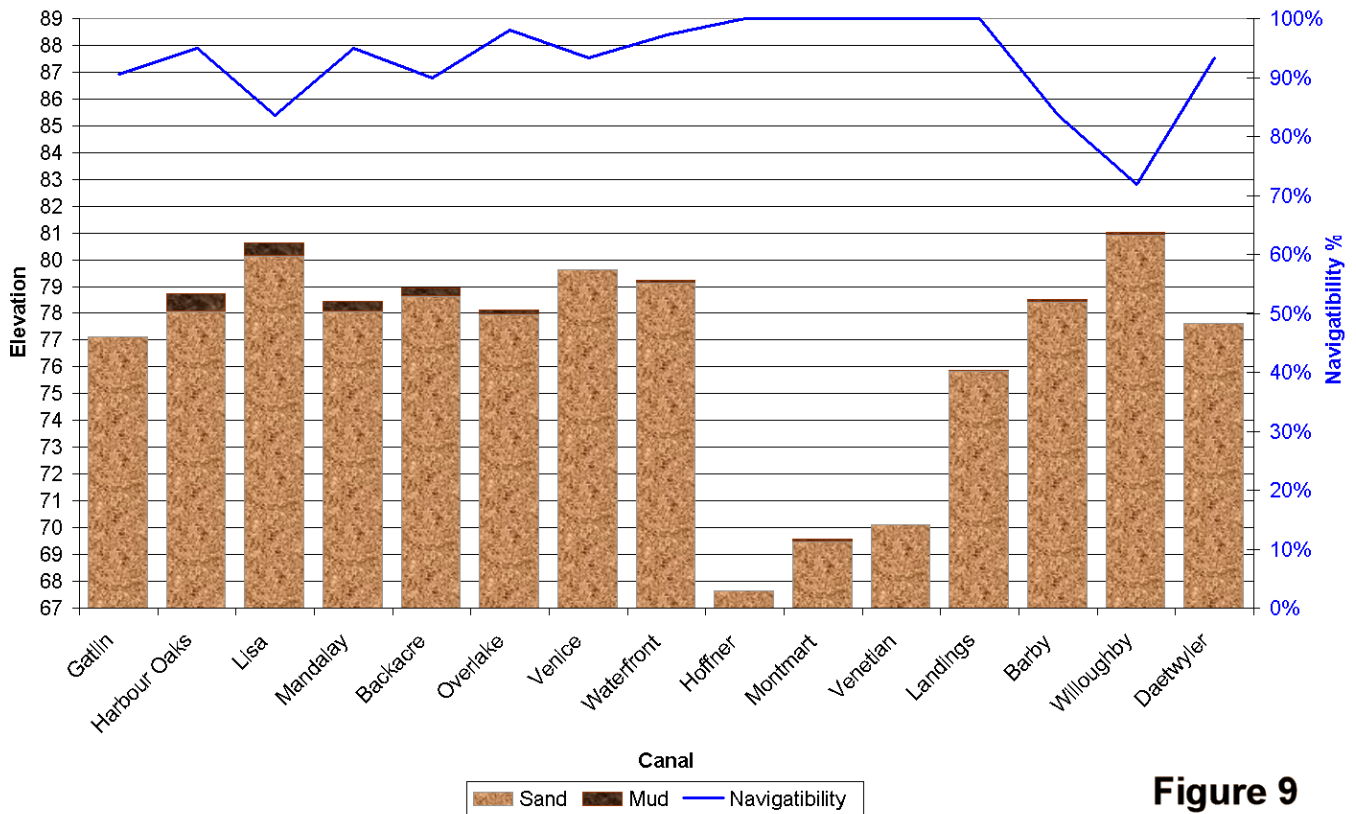
Figure 9

Lake Conway 2010 Minimum Canal Bottom Elevations

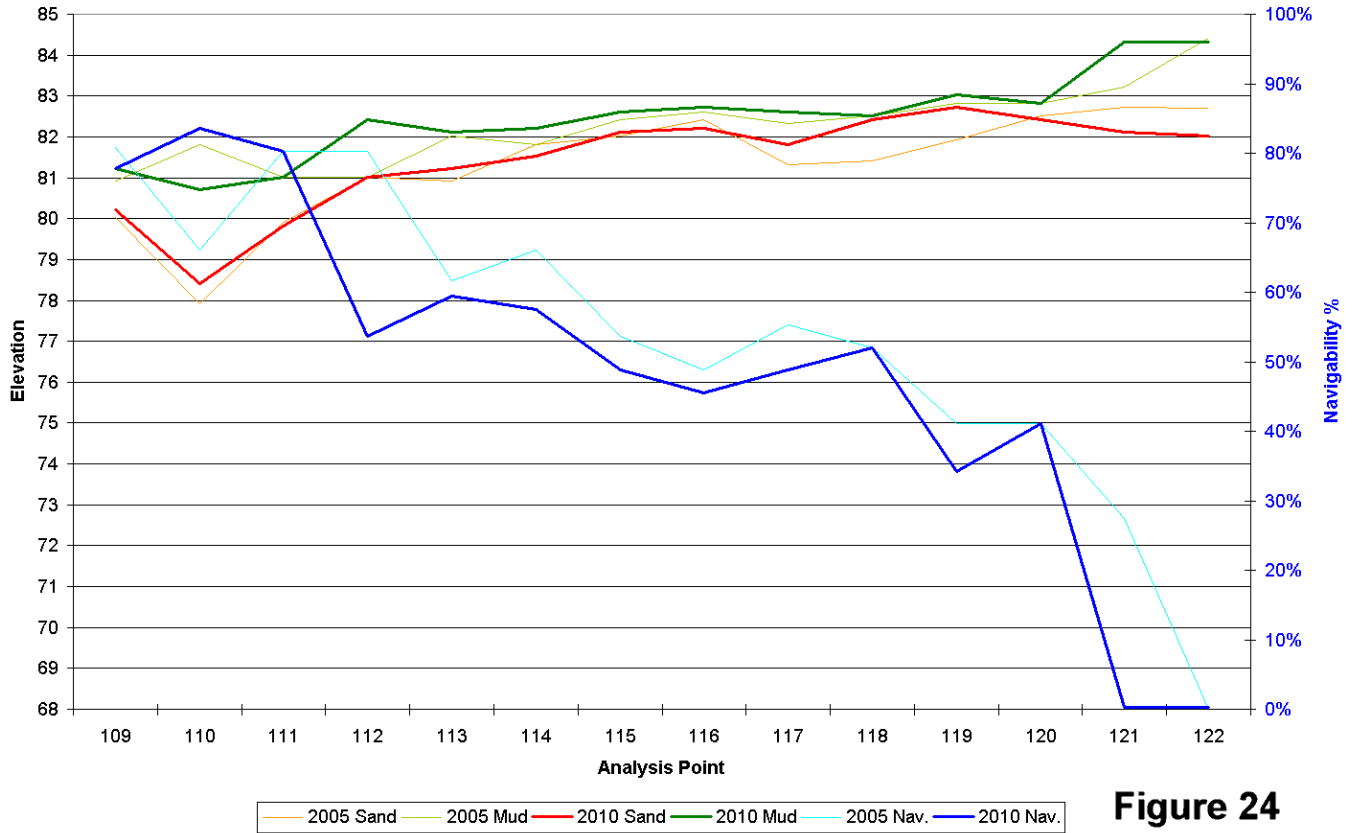
Figure 24

Barby – Probe 110 – This area appears to have been scoured by propeller wash during a period of low water (2007) between measurements. This canal is in the poorest overall condition of those surveyed.

The only canals which improved in the last 5 years are those which have been de-mucked or dredged. The others have, on the average, decreased their navigability by only 2.3%. The de-mucked canals have navigability which has improved by 25% for Lisa, 3% for Venice, and 19% for Venetian. Gatlin canal is virtually unchanged. The canals in the poorest condition are Barby and Willoughby.

Barby Canal 2005 - 2010 Bottom Elevations

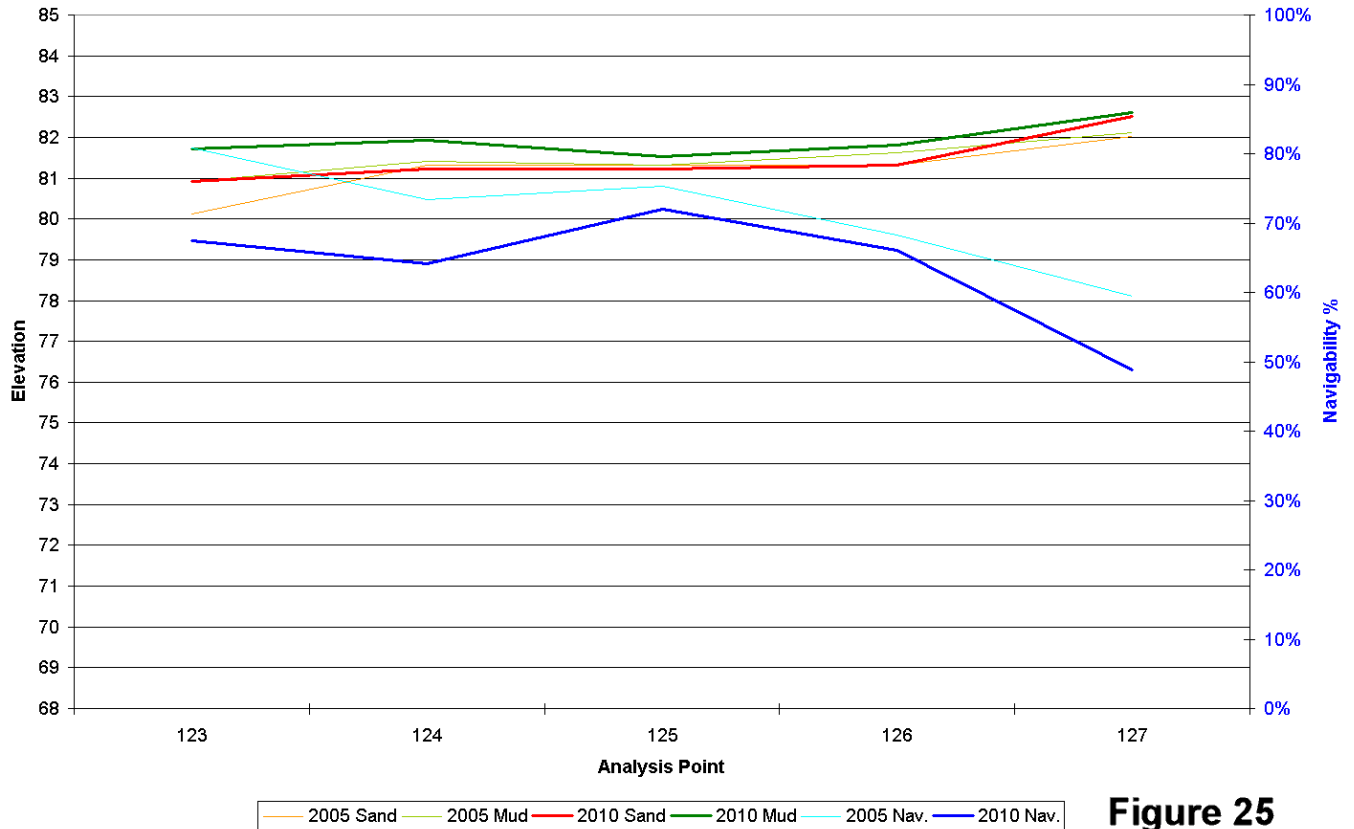
Figure 25

Willoughby Canal 2005 - 2010 Bottom Elevations
