Lake Conway Canal Siltation Study

Technical Memorandum

August 2021

Orange County Environmental Protection Division

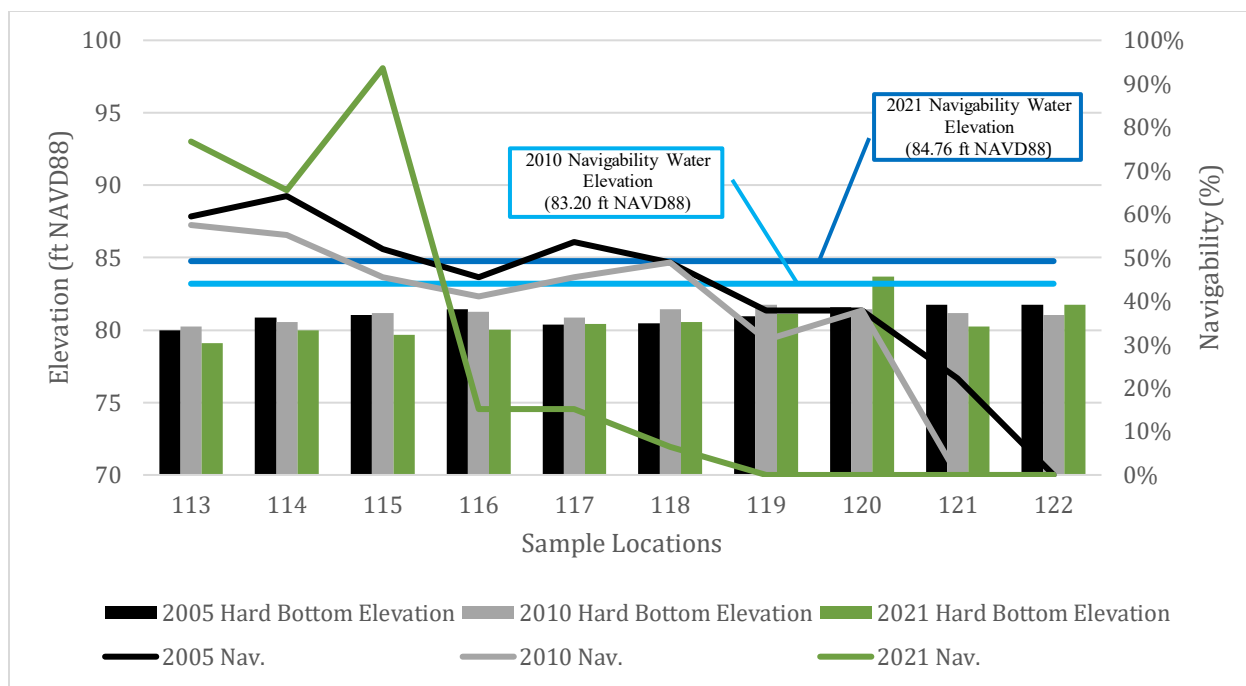
Figure E-2: Barby Canal

Barby – Probe 110 – This area appears to have been scoured by propeller wash during a period of low water (2007) between measurements. This canal is in the poorest overall condition of those surveyed.
